2.7 Geologic Resources

Geologic surveys and analyses of the Shadow Run Ranch TM 5223RPL³ project site were conducted by URS Corporation. Their report, “Geotechnical Evaluations, Existing Water Storage Reservoir, Proposed Shadow Run Ranch Residential Development, Pauma Valley, North San Diego County, California,” dated November 25, 2013, is included as Appendix H.

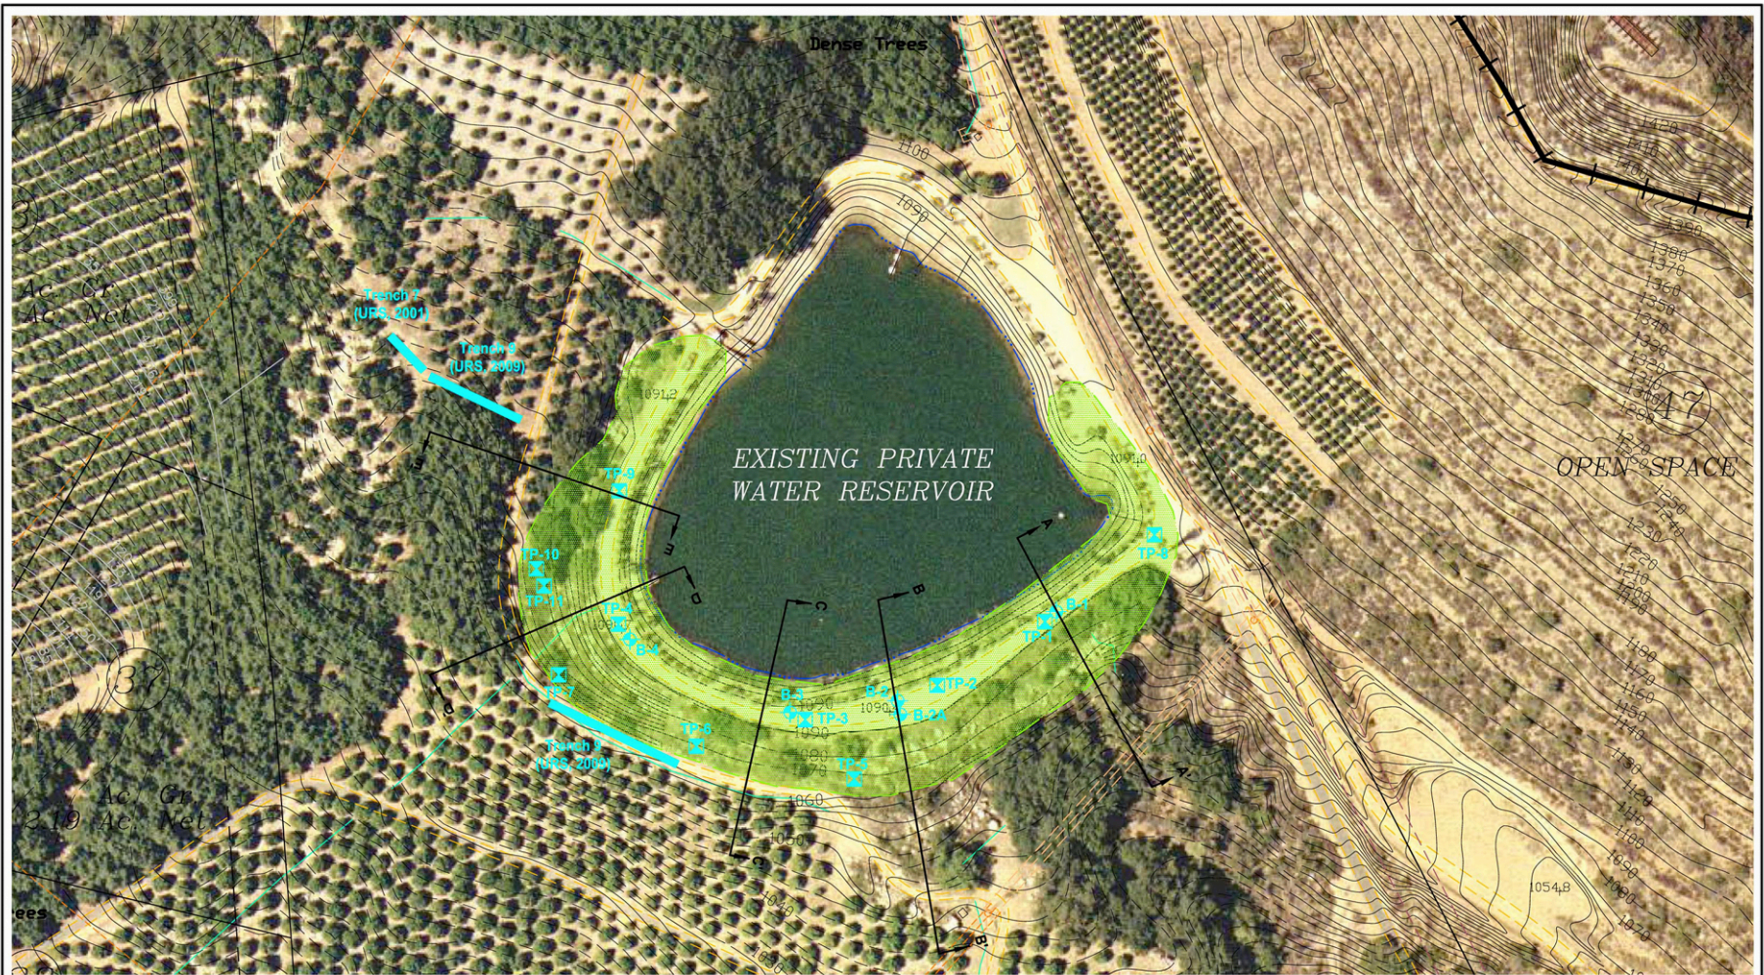
Figure
2-7-2

Topographic Map of Existing Reservoir

The stability of the existing onsite reservoir embankment was investigated for potential hazards. A fill slope bounds the reservoir to the west and south, as shown in Figure 2-7-2, "Topographic Maps of Existing Reservoir." The embankment fill slope is approximately 25 feet in height and has downstream slopes between approximately 2.5:1 and 3:1. The fill slope toe is along the top of stockpiled boulders in some areas. Figure 2-7-3, "Cross-sections of Reservoir," show the maximum water level relative to limits of fill.
